SURVEY REPORT  
on  
DEFORMATION ANALYSIS  
De Tijger Slope

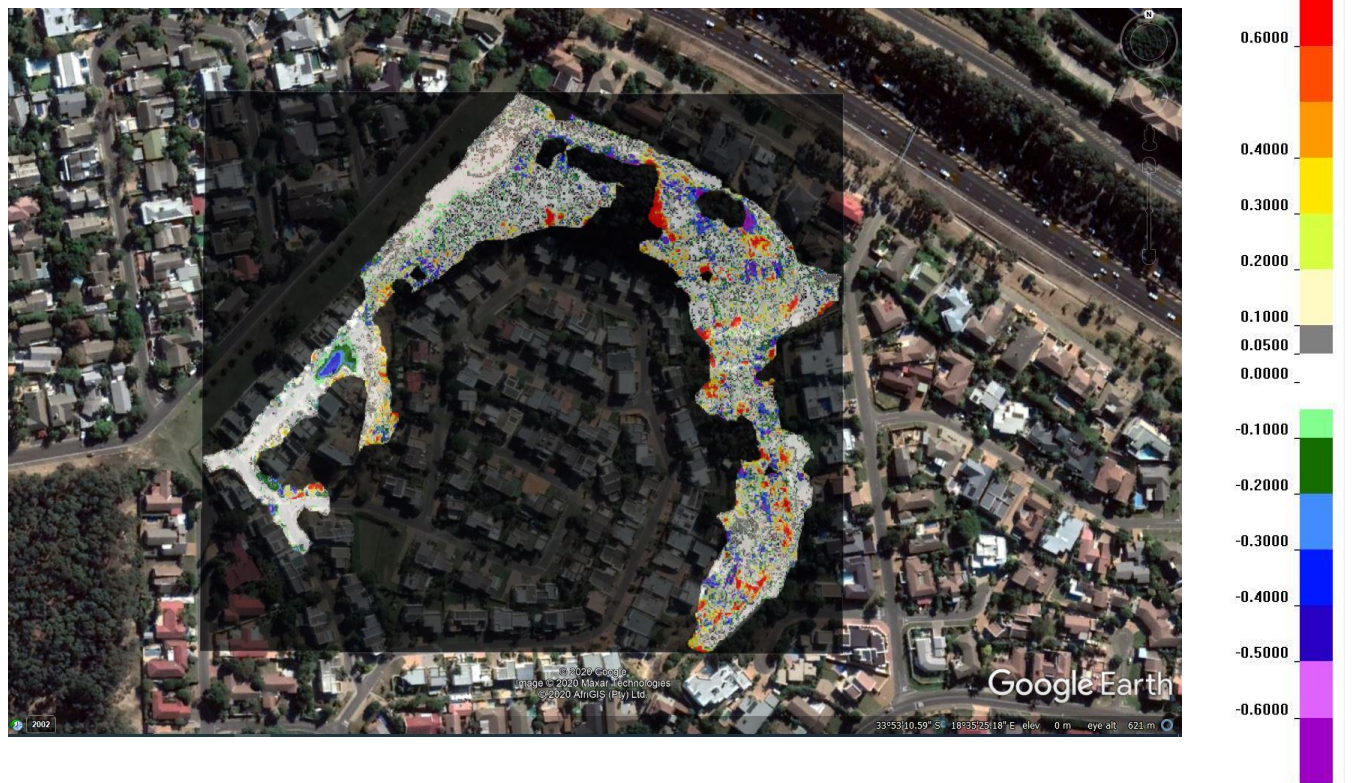
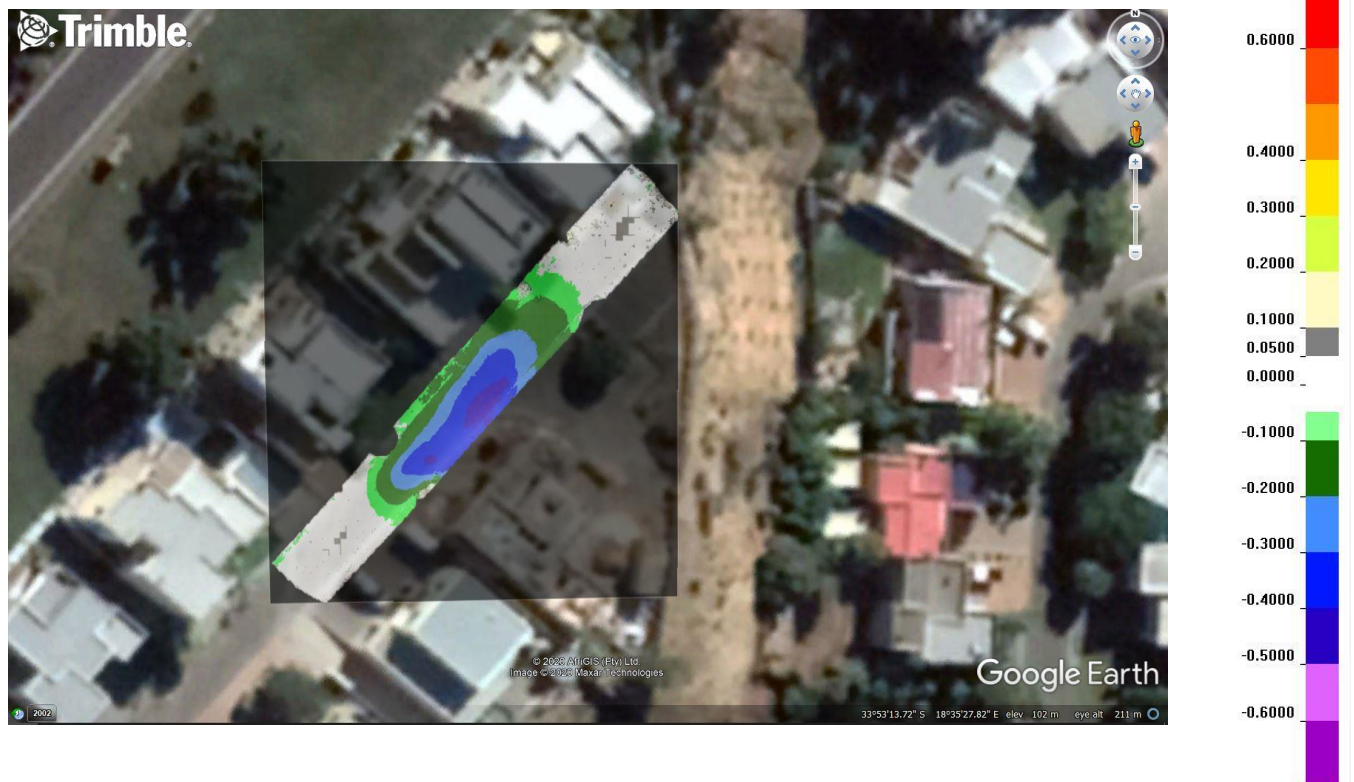
Positive values indicate the surface has risen  
Negative values indicate the surface has sunk

Some notable deformation is seen on Dauphine street where the road has sunk. The surface analysis shows the that road has sunk up to 45cm in some areas.
